Operation and Maintenance for Passive Treatment systems

***Somerset County
Conservation District***
*1590 North Center Avenue, Suite 103
Somerset, PA 15501*

Damariscotta
*650 Merle Street, Suite C
Clarion, PA 16214*

June 2003

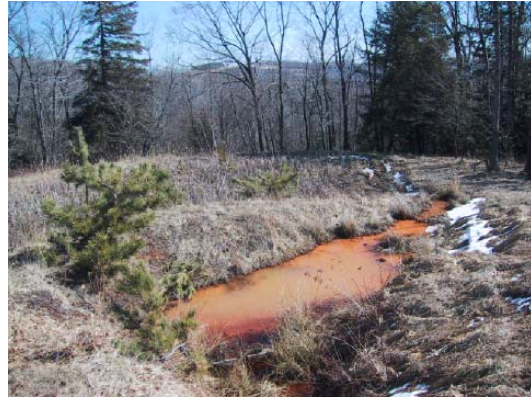
Figure 1. Typical Aerobic Wetland, Garrett County, Maryland.

As mentioned previously, the first wetlands designed for mine drainage treatment, were intended to mimic natural wetlands (actually *Sphagnum* spp. peat wetlands). These natural wetlands, that received mine water, were observed ameliorating the drainage to some degree (i.e. removed some metals and pH values improved). The first attempts utilized *Sphagnum* (Weider, 1985), while later efforts utilized cattails (Hedin and others, 1994a; Skousen and others, 2000; see Figure 1).

These types of wetlands typically were shallow (1 foot or less) water, with the vegetation planted in organic material or available on-site material. The aeration that these types of wetlands typically provide, allows for the oxidation of Fe^{2+} and ultimately its precipitation and deposition (given adequate detention time) as FeOOH . Aerobic wetlands have proven acceptable treatment when the water is net alkaline, with iron concentrations not exceeding the alkalinity available to precipitate it (given oxygen and time) or mildly acidic water with little iron. Aluminum is typically not a design criteria, as the pH is such that if aluminum is present it is typically precipitated within the first portion of

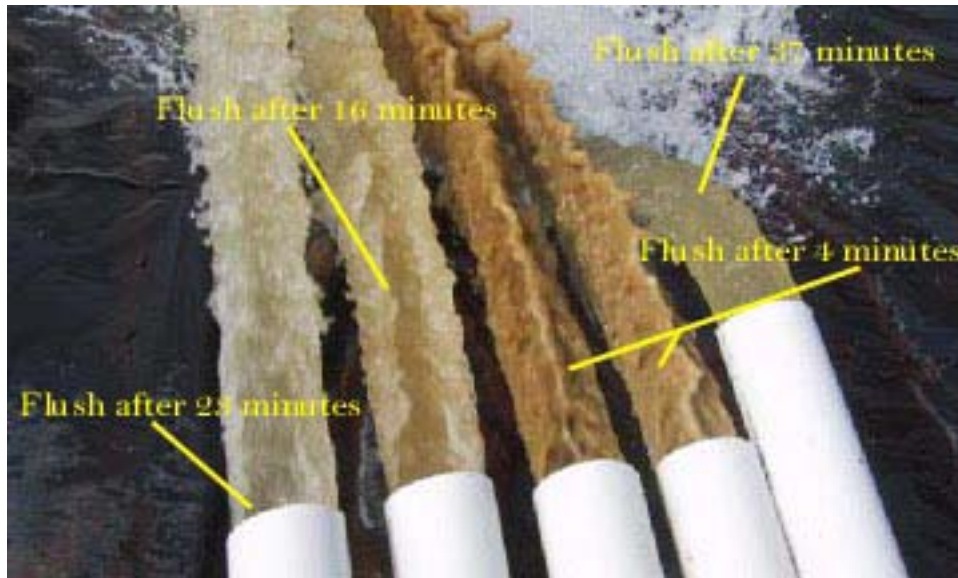
Figure 5. Various flush times (and associated colors) on a SAPS system in Somerset County, Pennsylvania (August 2002).

near future *or* required immediately then the first step is to “flush” the SAPS unit with the valve structures that are incorporated into the SAPS unit for this purpose. Flushing intervals are typically not pre-determined but are set post-construction following a year (typically) of treatment and water monitoring. Flushing consists of drawing the water from the underdrain system bedded within the limestone to remove metal accumulation, precipitated in the limestone layer, that interferes with normal flow and treatment. The flushing event can last from as little as 10 minutes to as long as 60 minutes, and is dependant on the flush water color – the flush should cease when the water appears relatively clear (see Figure 5 for comparative flush colors).

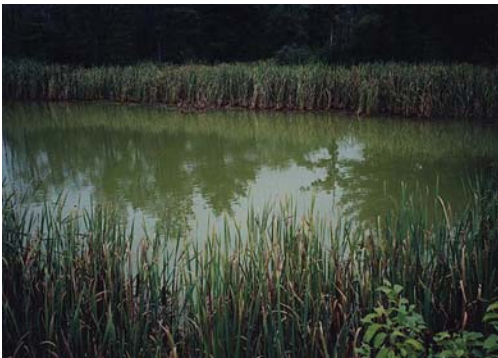
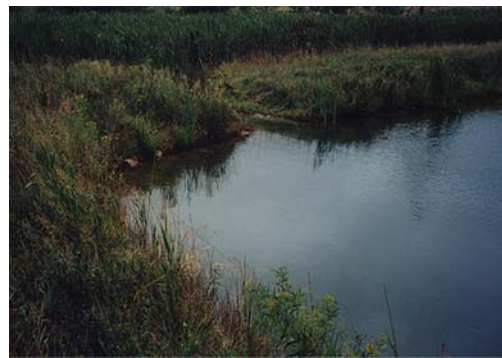
Figures T2 & T3. Photographs of the SAPS and settling basin as a part of the Tangascootack treatment system. Beech Creek Township, Clinton County, Pennsylvania.

The SAPS was designed with bottom dimensions of 30' x 120' and with 2:1 inslopes. The wetted area therefore encompasses roughly 66' x 156', or 0.25 acres. The as-built drawings (Appendix 1) show that 2.2' of No. 57 limestone² (500 tons) was placed on the bottom of the treatment unit, covered by 1.0' of mushroom compost, and roughly 6.0' of freestanding water.

The SAPS was designed with a collection pipe system placed directly on the bottom of the treatment unit. The pipes were 4" perforated, corrugated sewer pipe, placed on 5' centers and running the length of the unit. The six total pipes equaled 720' and were

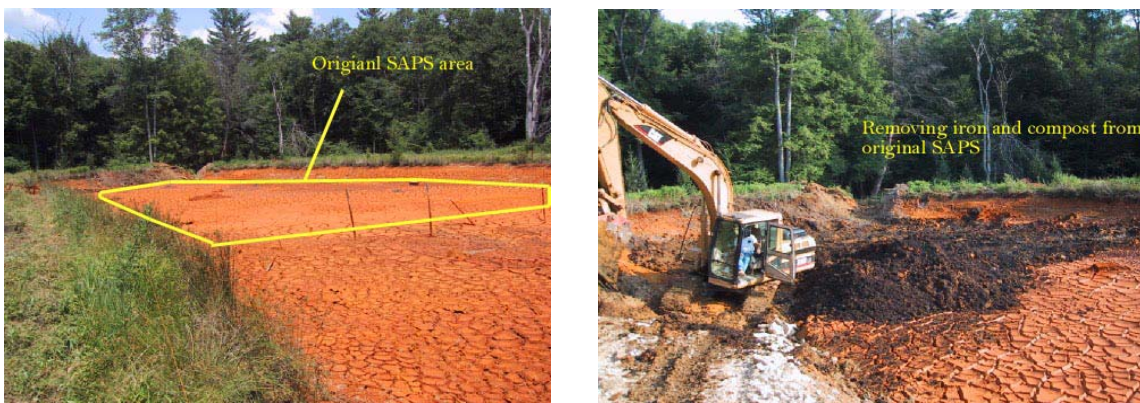
Figure H3 & H4. SAPS reconstruction at Howe Bridge in 2002, Corsica, Pennsylvania.

The original SAPS that was placed at the end of the system was reconstructed by: 1) removing the accumulated iron precipitate; 2) removing compost and stockpiling compost that could be reused; 3) removing the old black flexible piping system; 4) installing new piping system with perforated SDR 26 - 4" pipe; 5) adding additional limestone, approximately 500 tons; 6) replacing compost that could be reused and adding additional new compost; and 7) installing new discharge pipes at a new location to pool water before discharging into Mill Creek (a precaution to remove any additional iron if present). Photographs of this reconstruction can be seen in Figures H3 and H4, as well as Figure 2.
