GILMORE RUN

GILMORE RUN SUBWATERSHED

ACID MINE DRAINAGE PROJECT
BIG SCRUBGRASS CREEK WATERSHED

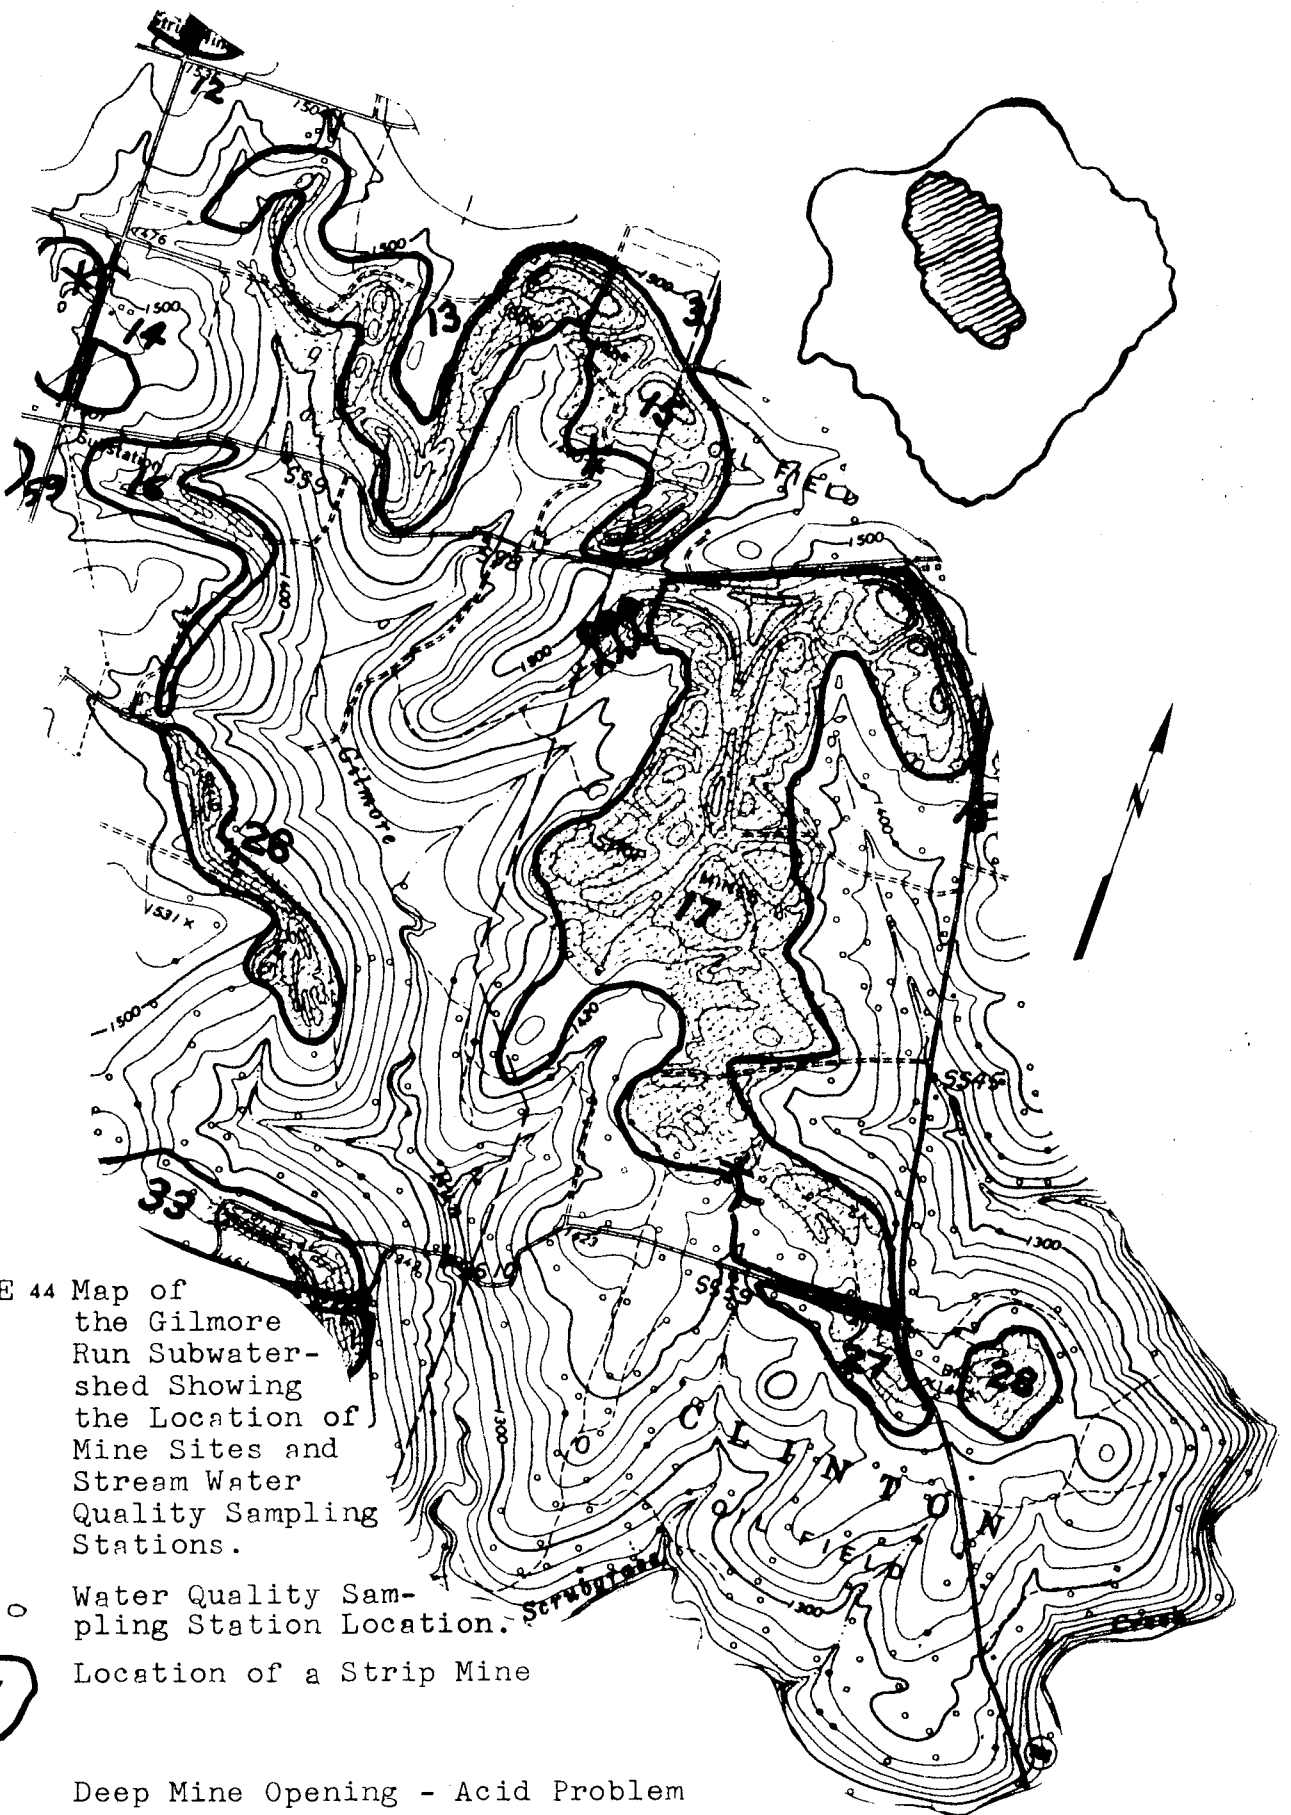
Six water quality sampling stations were set up in the Gilmore Run area. The location, drainage area and summary of water quality test results are contained in the following discussion. The location of the sampling stations are shown on the map, Figure 44.

FIGURE 44 Map of the Gilmore Run Subwatershed Showing the Location of Mine Sites and Stream Water Quality Sampling Stations.

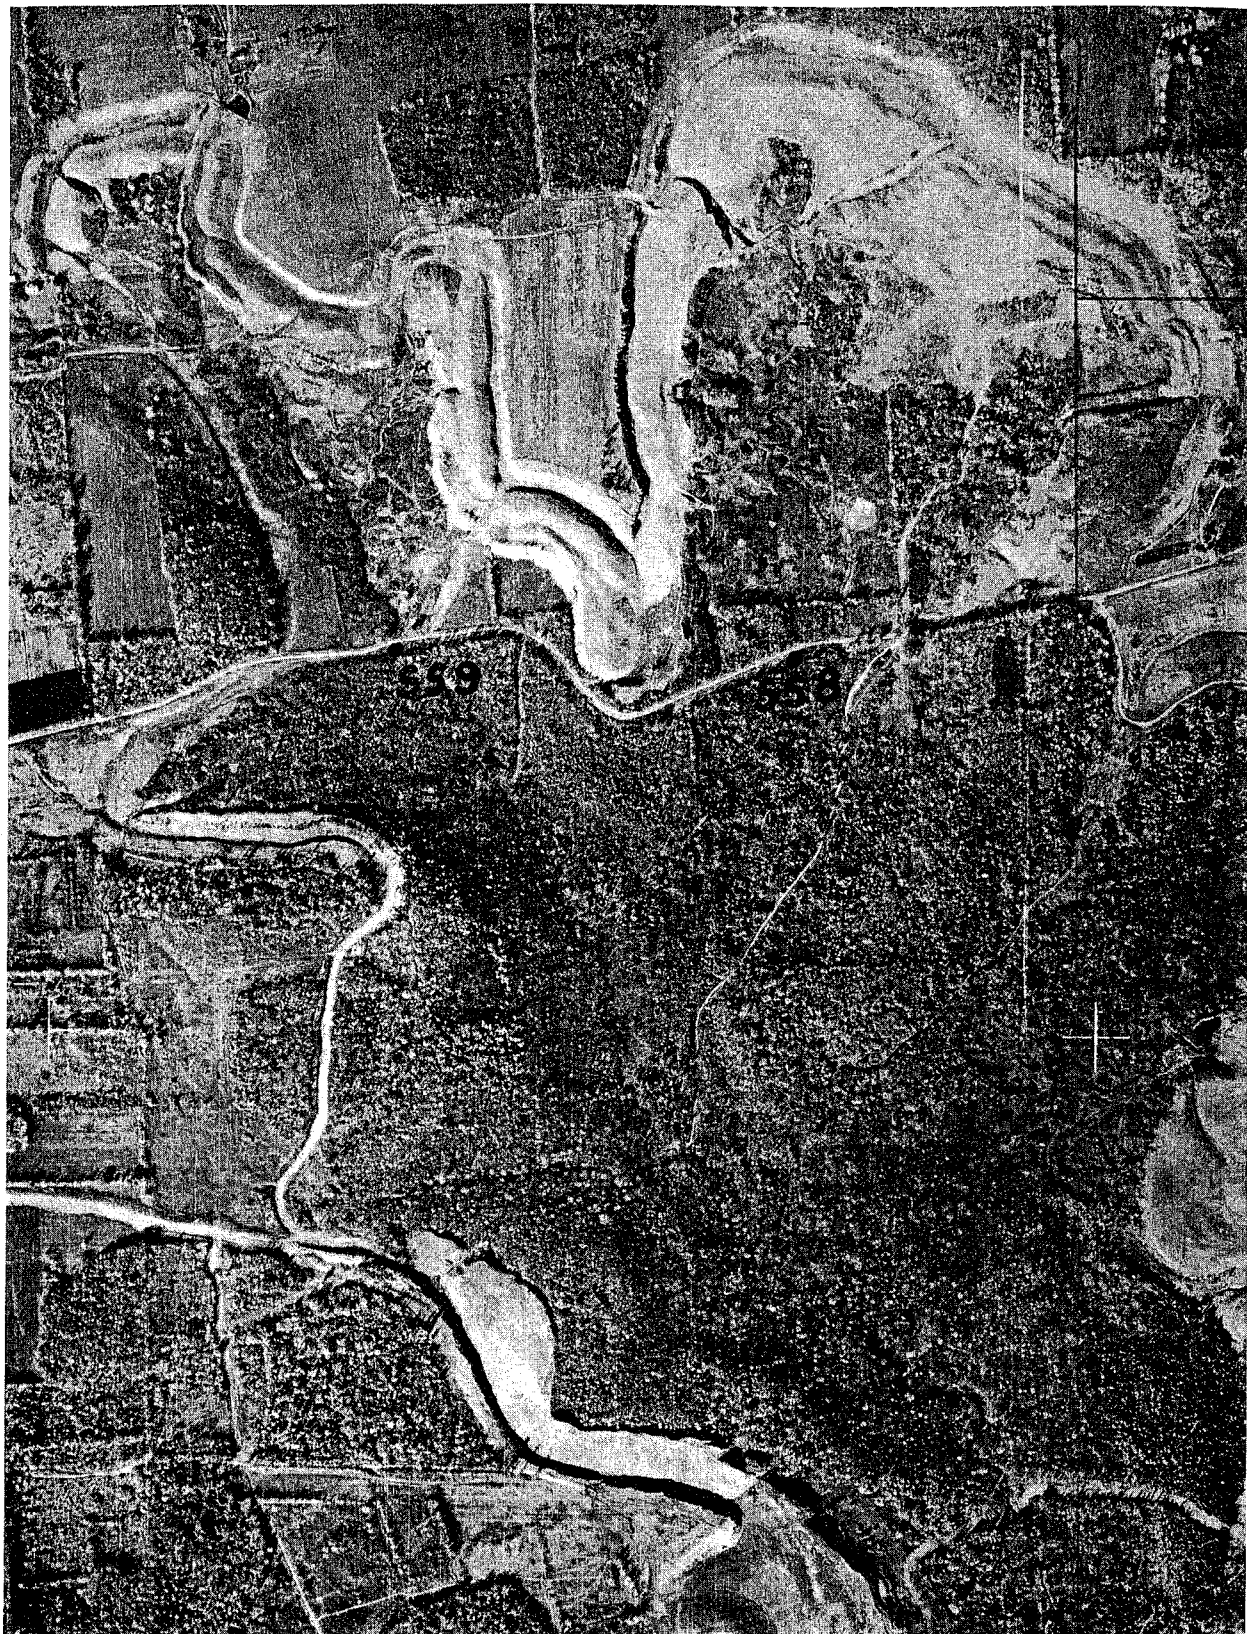
Figure 45 . Aerial Photo Showing
Mine Sites Nos. 13, 15, 16 and 26.
Scale: 1 in. = 1000 ft.

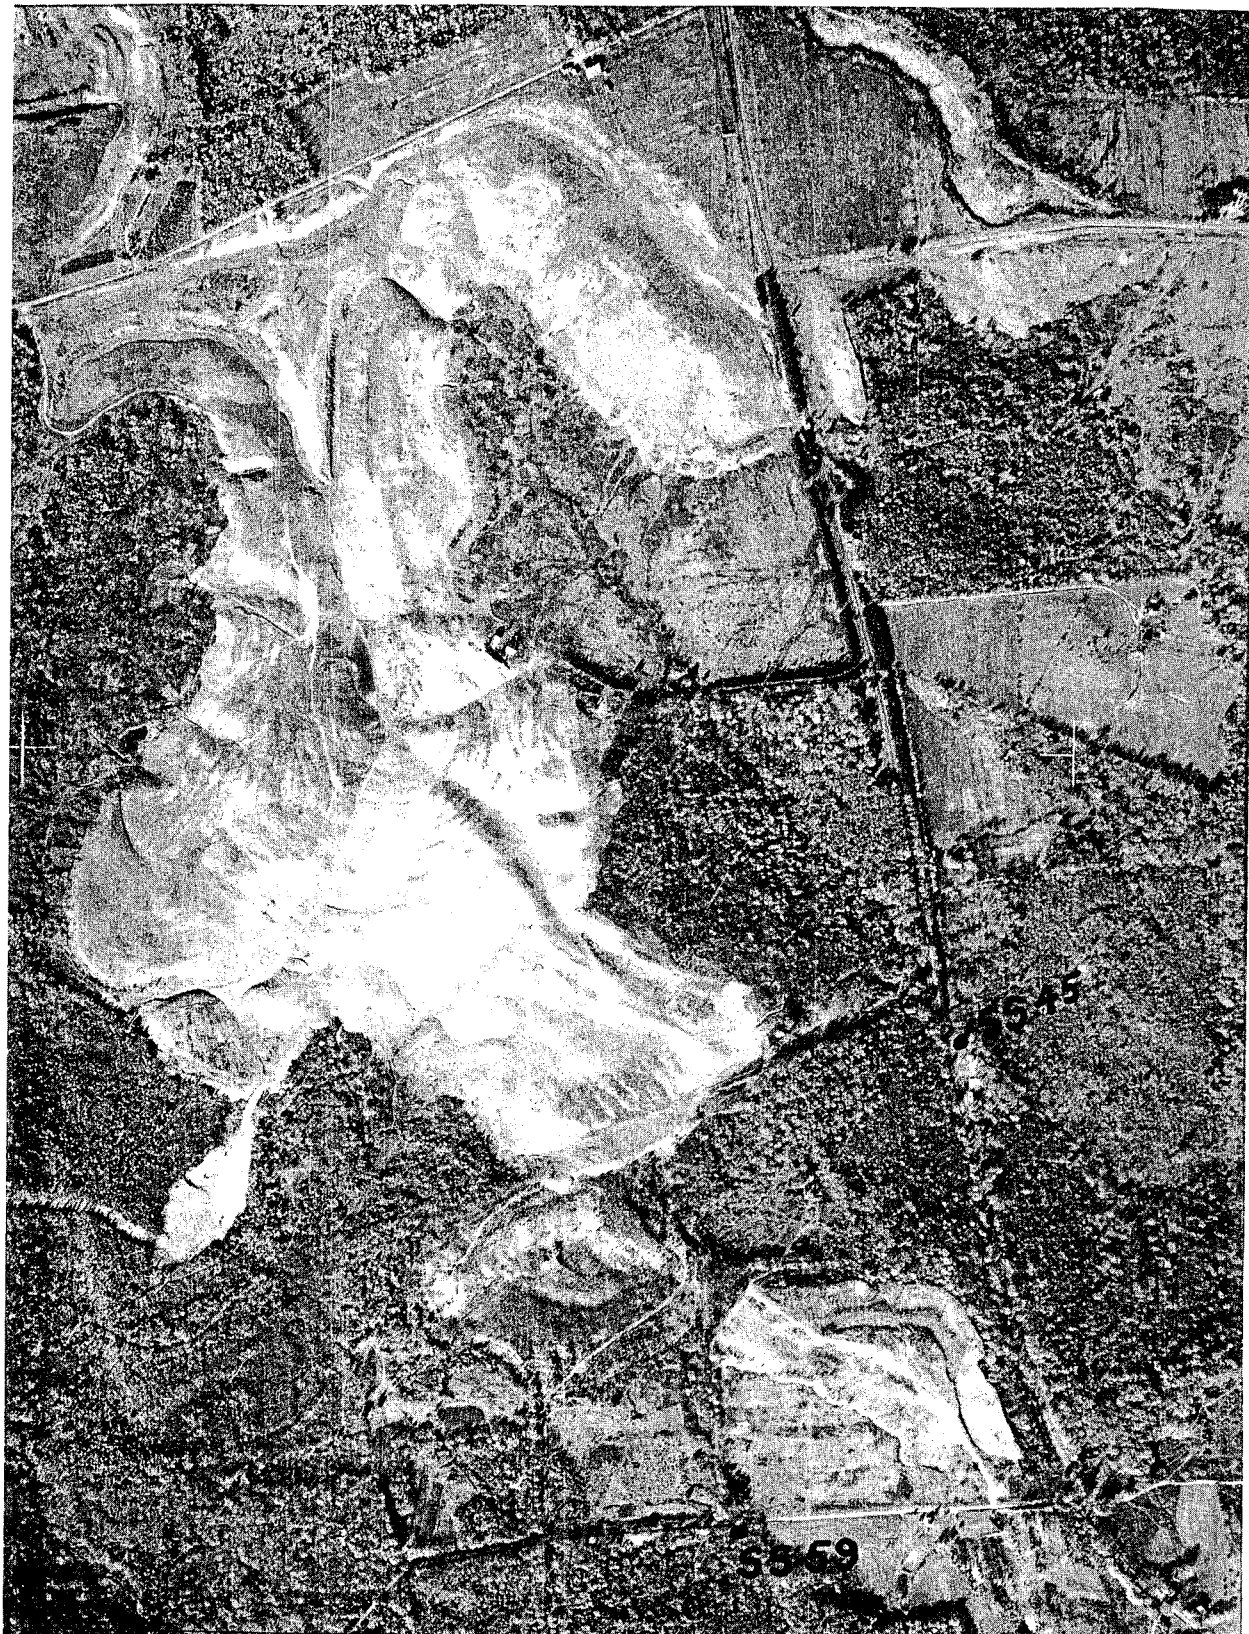
Figure 46 . Aerial Photo Showing
Mine Site No. 17. Scale: 1 in. = 1000 ft.

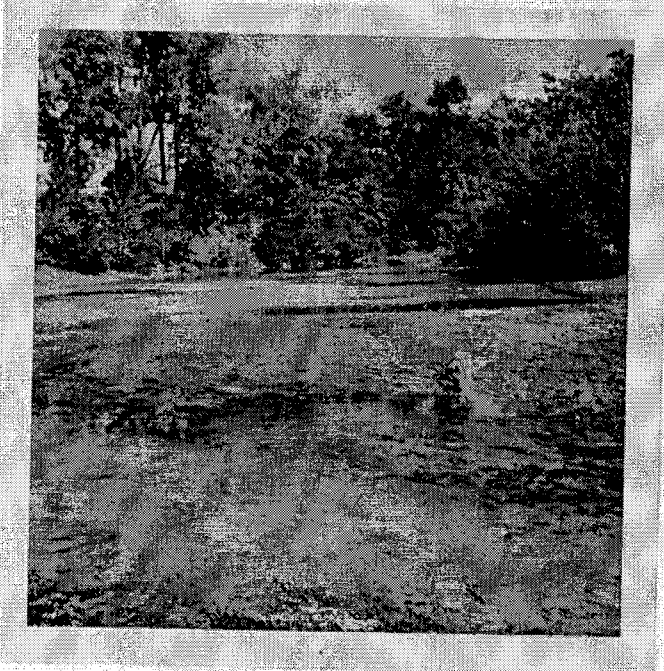
Figure 47. This large seepage area at the southeast edge of Area 18 is just one of many found around the edge of Mine 17. This mine is the largest single source of acid mine drainage in the Big Scrubgrass Creek Watershed.

Areas #16 and #18 cover 13.2 acres of gently rolling spoil material with about 50 percent bare area which contributes to acid runoff during storms. An area of heavy seepage exists on the southeastern edge of Area #18 (See Figure 47). If this does not clear up after surface reclamation of the area it should be investigated by drilling to determine if the area was disturbed at one time by deep mining. For the present the area should be seeded using revegetation Method No. 1 to reduce the acid storm runoff.
