UPPER MAIN STREAM SUBWATERSHED

ACID MINE DRAINAGE PROJECT
BIG SCRUBGRASS CREEK WATERSHED

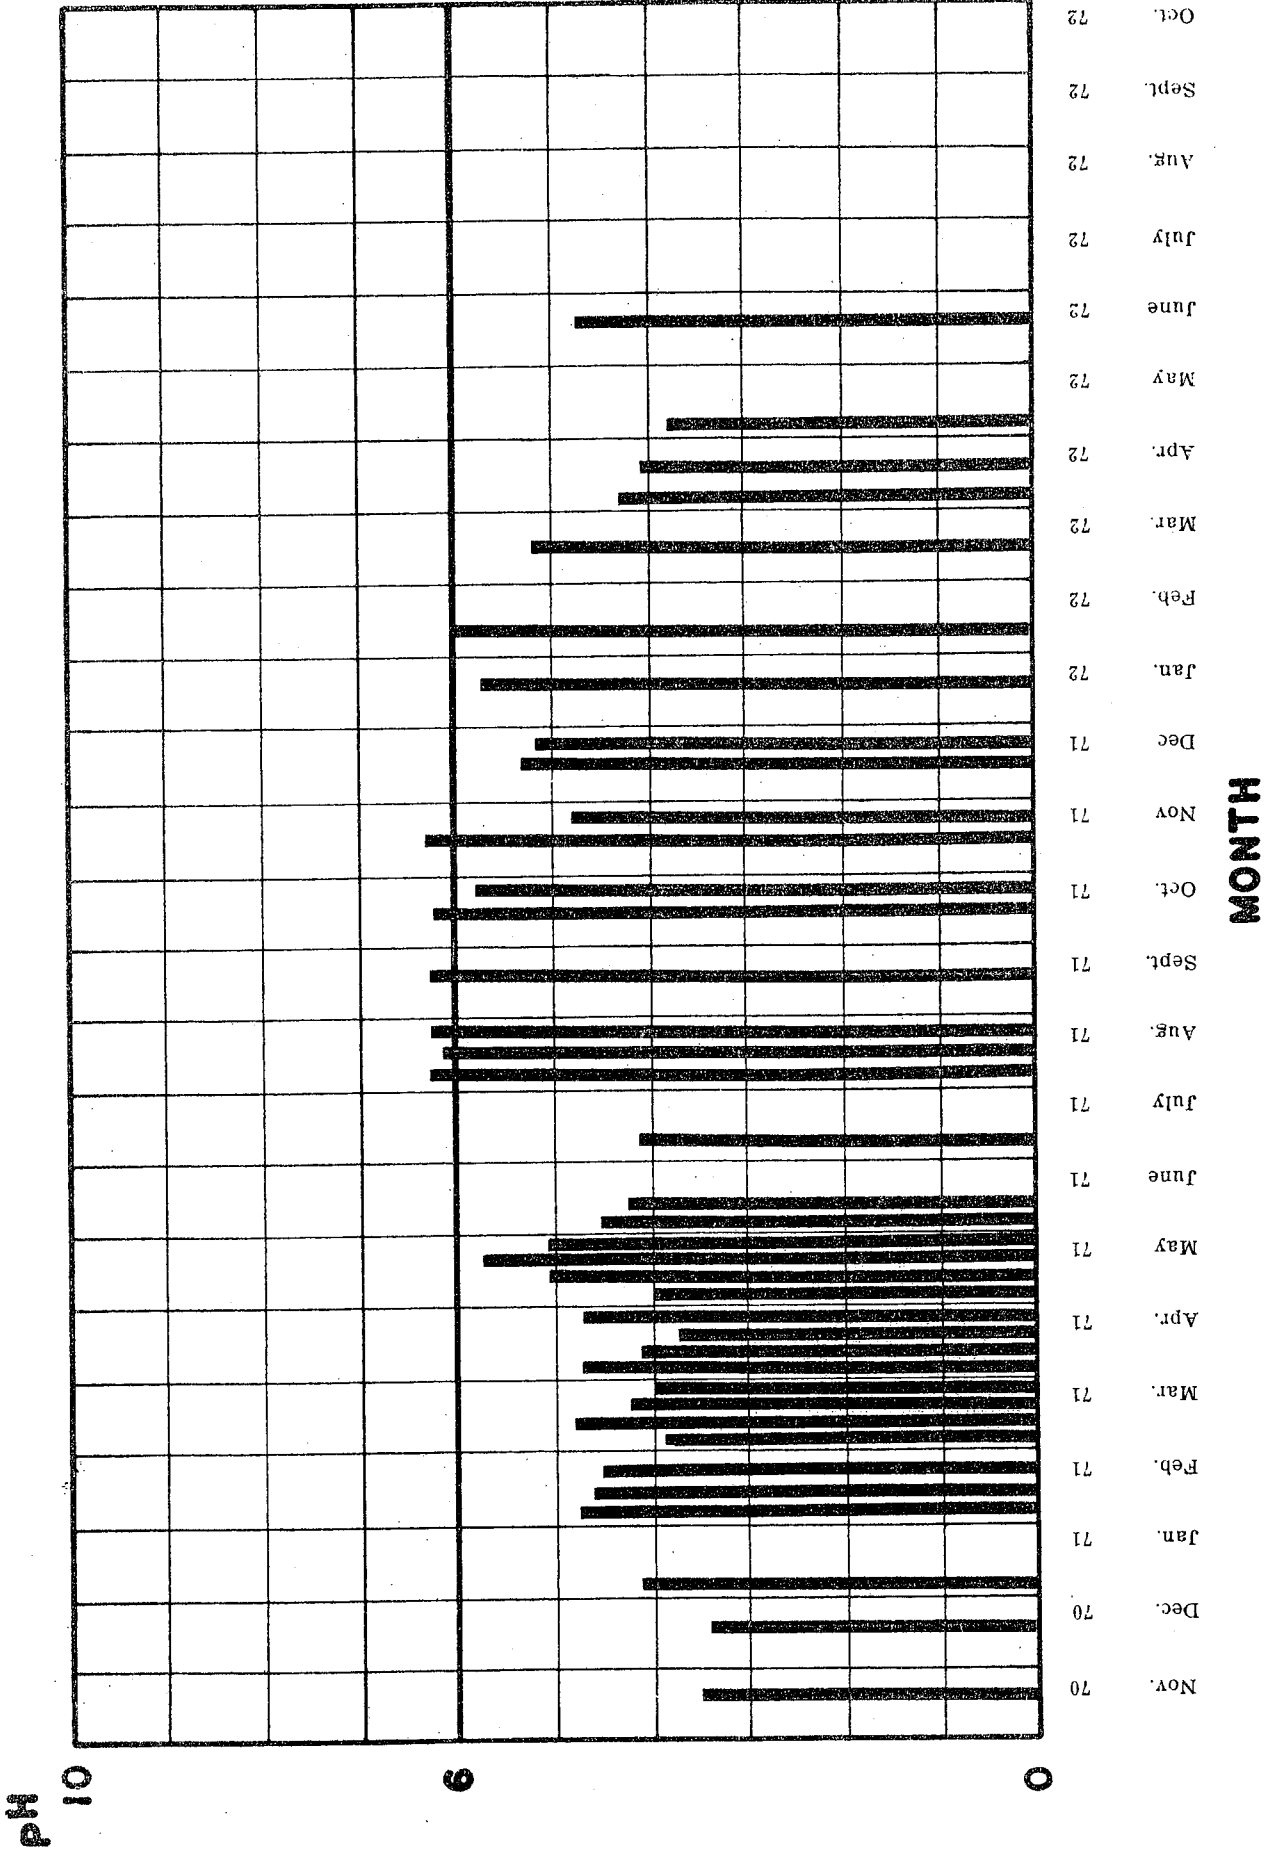
FIGURE 48

SAMPLING STATION NO. 14

Station No. 14 was on the main branch of Big Scrubgrass Creek, established at the south end of a bridge crossing under Township Road 325, .6 miles east of the junction with L.R. 60003.

There are 3.7 square miles of drainage area above this station and it collects flows from Mine Sites No. 10, No. 11, No. 12, No. 14, No. 21, No. 23, No. 24, No. 25 and No. 59. This station was sampled 39 times between November 20, 1970 and June 23, 1972, resulting in the following average, maximum and minimum water quality analysis.

<u>Average</u>	<u>Maximum</u>	<u>Minimum</u>
Flow (gpm)	2771	46200	760
pH	4.8	6.3	3.4
Total Acidity (ppm)	41.0	60.0	10.0
Alkalinity (ppm)	1.3	10.0	0.0
Iron (ppm)	0.37	1.5	0.175
Sulfates (ppm)	184.0	260.0	42.0
Acid (ppd)	1371.0	5500.0	365.0
Alkalinity (ppd)	39.0	360.0	0.0
Iron (ppd)	13.0	69.0	1.0
Sulfates (ppd)	6771.0	23300.0	2100.0

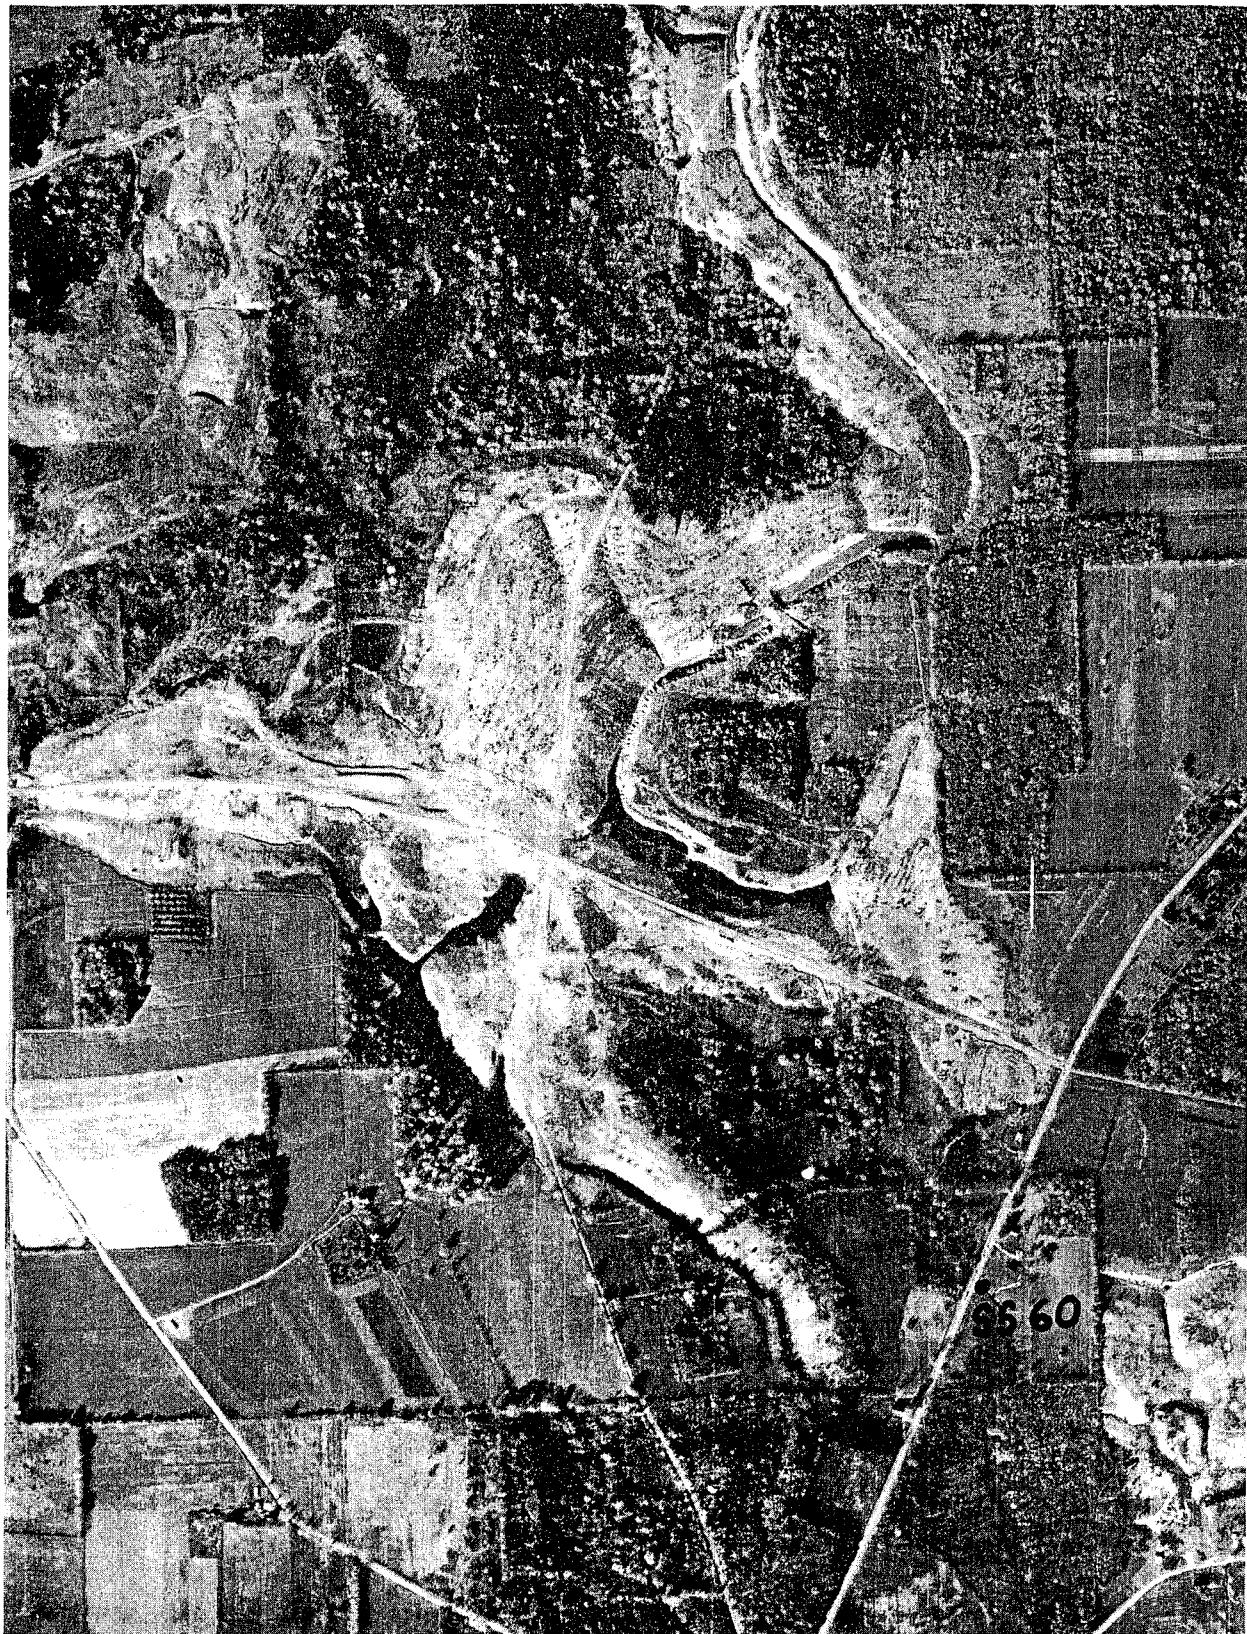
Figure 51 . Aerial Photo Showing
Mine Site No. 10. Scale: 1 in. = 1000 ft.

This strip mine covers 219 acres in the headwaters of Big Scrubgrass Creek with some drainage going northwest into the South Sandy Creek Watershed. This mine contains more acid pools than any other in the watershed. Sampling Station No. 60 collected most of the drainage from this mine and had an average acid discharge of 326 pounds per day. The northern part of this mine lies on the edge of State Game Land No. 39. Two deep mine openings were reported near the eastern edge of Site #10 but field investigations revealed no evidence of seepage. One of the mines had been sealed by the Pennsylvania Department of Transportation.

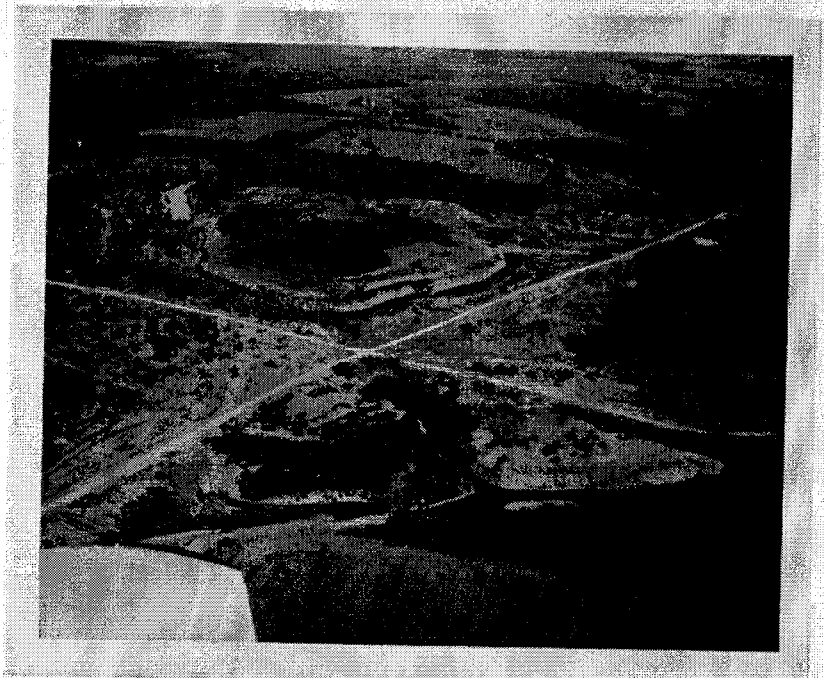
Figure 52. Aerial view of mine site 10 looking north-east. Note the coal spoil at the upper end of pool area 16 in the left foreground and the dark color of the water in pool 18. This mine is the source of more than 300 pounds of acid per day discharge into the Upper Main Stream.

Areas #16, #18 and #25 cover 20.2 acres of extremely acid spoil, coal waste and acid pools. (See Figure 52). The spoil pH is less than 3.0 and the pools have water with as much as 860 parts per million acid. The source of the acid in the pools is in runoff from the spoil and coal waste. The pools should be drained by cutting drainage ditches to allow surface drainage through point "f". The pool areas should then be partially backfilled including burial of the coal waste under at least 5 feet of compacted neutral soil containing at least 20 percent clay. The area should then be regraded and some type of organic soil conditioner such as wood chips, animal manure or sewage sludge mixed into the top foot of soil at a rate of not less than 200 tons per acre. The area should then be reseeded using revegetation Method No. 1.

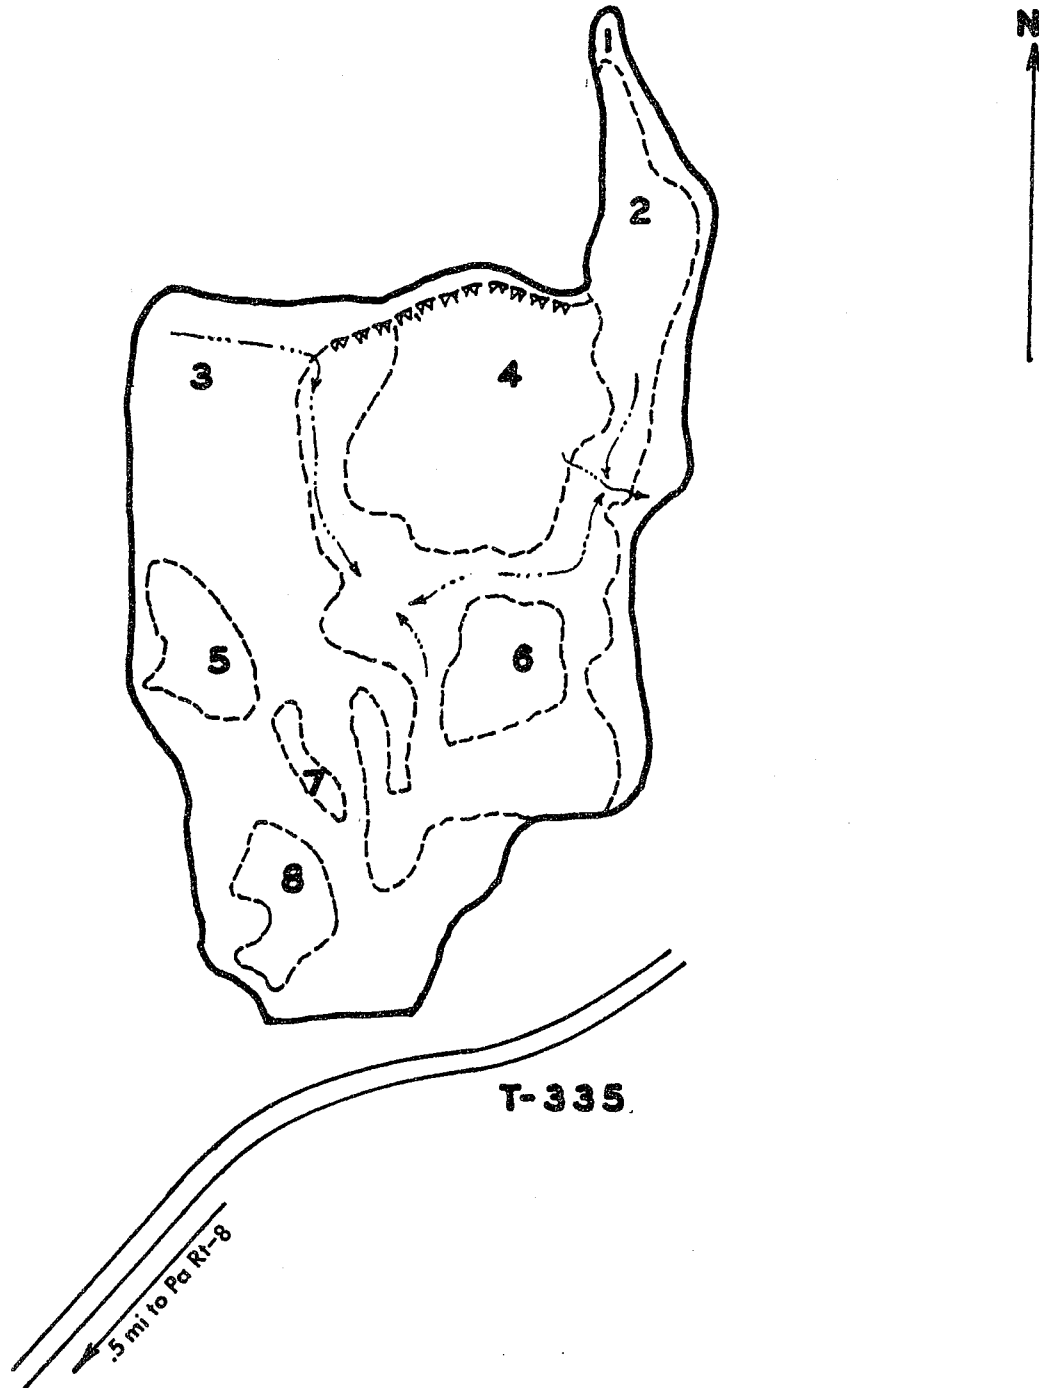
SITE II

Mine Site No. 11 covers 33.6 acres of old strip mine along T-335 in the Upper Main Stream Subwatershed. Most of the area is rough mine spoil covered with pine trees 10 to 20 years old. The spoil pH is 4.2 to 4.8. A small tributary stream passes along the eastern side of this site. Sampling Station No. 38 was located above the site and Sampling Station No. 11 was located below the site. The acid content of this stream increased 71 pounds per day between these two stations. Additional seepage emerges from the southern edge of the mine which would not pass through Sampling Station No. 11. This seepage was highly acid, but occurred over such a large area that measurement of quantities was impossible. However, it was estimated to be approximately as great as that emerging on the east side. This seepage apparently resulted from acid runoff of bare spoil infiltrating the spoil in some poorly drained areas.

Areas #1, #3, #4 and #6 cover 21.5 acres which are adequately covered to prevent acid formation.

Areas #2 covers 9.8 acres of bare spoil material. About half of this area needs selected grading to provide adequate drainage and produce stable slopes. The entire area should then be reseeded using revegetation Method No. 1.

Areas #5, #7 and #8 cover 2.3 acres of rough bare spoil with unstable slopes which produce acid storm runoff. These areas should be regraded to produce stable slopes and reseeded using revegetation Method No. 1.

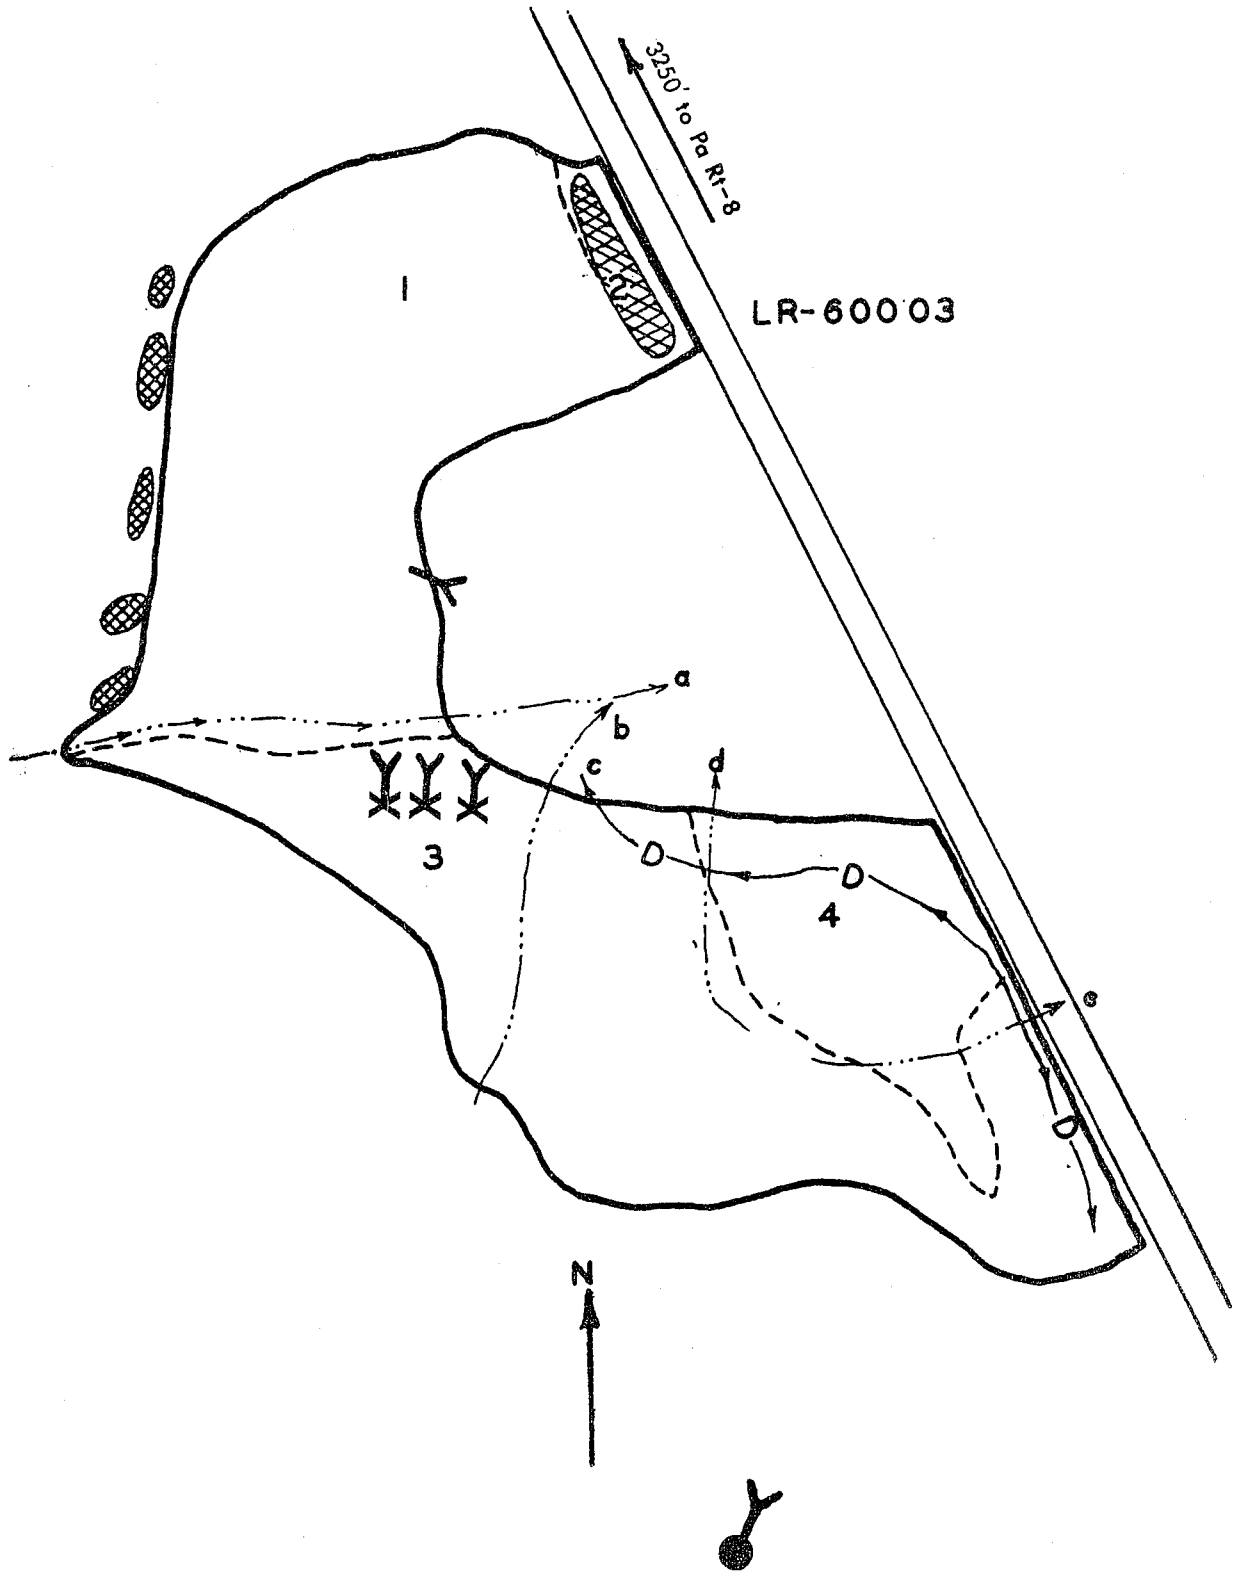
SITE 23

Site 23 includes 46.5 acres of strip mine and three old deep mine openings along L.R. 60003 on the extreme western edge of the watershed. Part of this site has been regraded and planted with grasses and legumes which have developed very good soil cover. The remainder of the area had topsoil saved but the regrading and planting were never completed. These areas are producing acid mine drainage during storm runoff. The old deep mine openings were from family mines and were very small. Only one is still actually in existence, the other two having been so small that the strip mining completely eliminated all traces of them. The remaining shaft is reported to have been a single tunnel about 400 feet long, and the opening, although caved in, is discharging some acid water.

Areas #1 and #2 include 20.6 acres of ungraded strip mine spoil and the area of stockpiled topsoil. The area is a source of acid storm runoff and should be regraded to fit the natural contours and the topsoil spread back over it. The area should then be reseeded using revegetation Method No. 1.

Area #3 includes 19.7 acres which need no additional reclamation.

Area #4 includes 6.2 acres of bare, eroding acid spoil which is a source of acid runoff. The area should be regraded to eliminate existing gullies and to construct a diversion to divert unpolluted water away from the acid spoil. The area should then be reseeded using revegetation Method No. 1. The old deep mine entry at the east

central edge of the mines should be investigated with a drilling and pressure testing program and from the data obtained a hydraulic seal should be designed and installed.

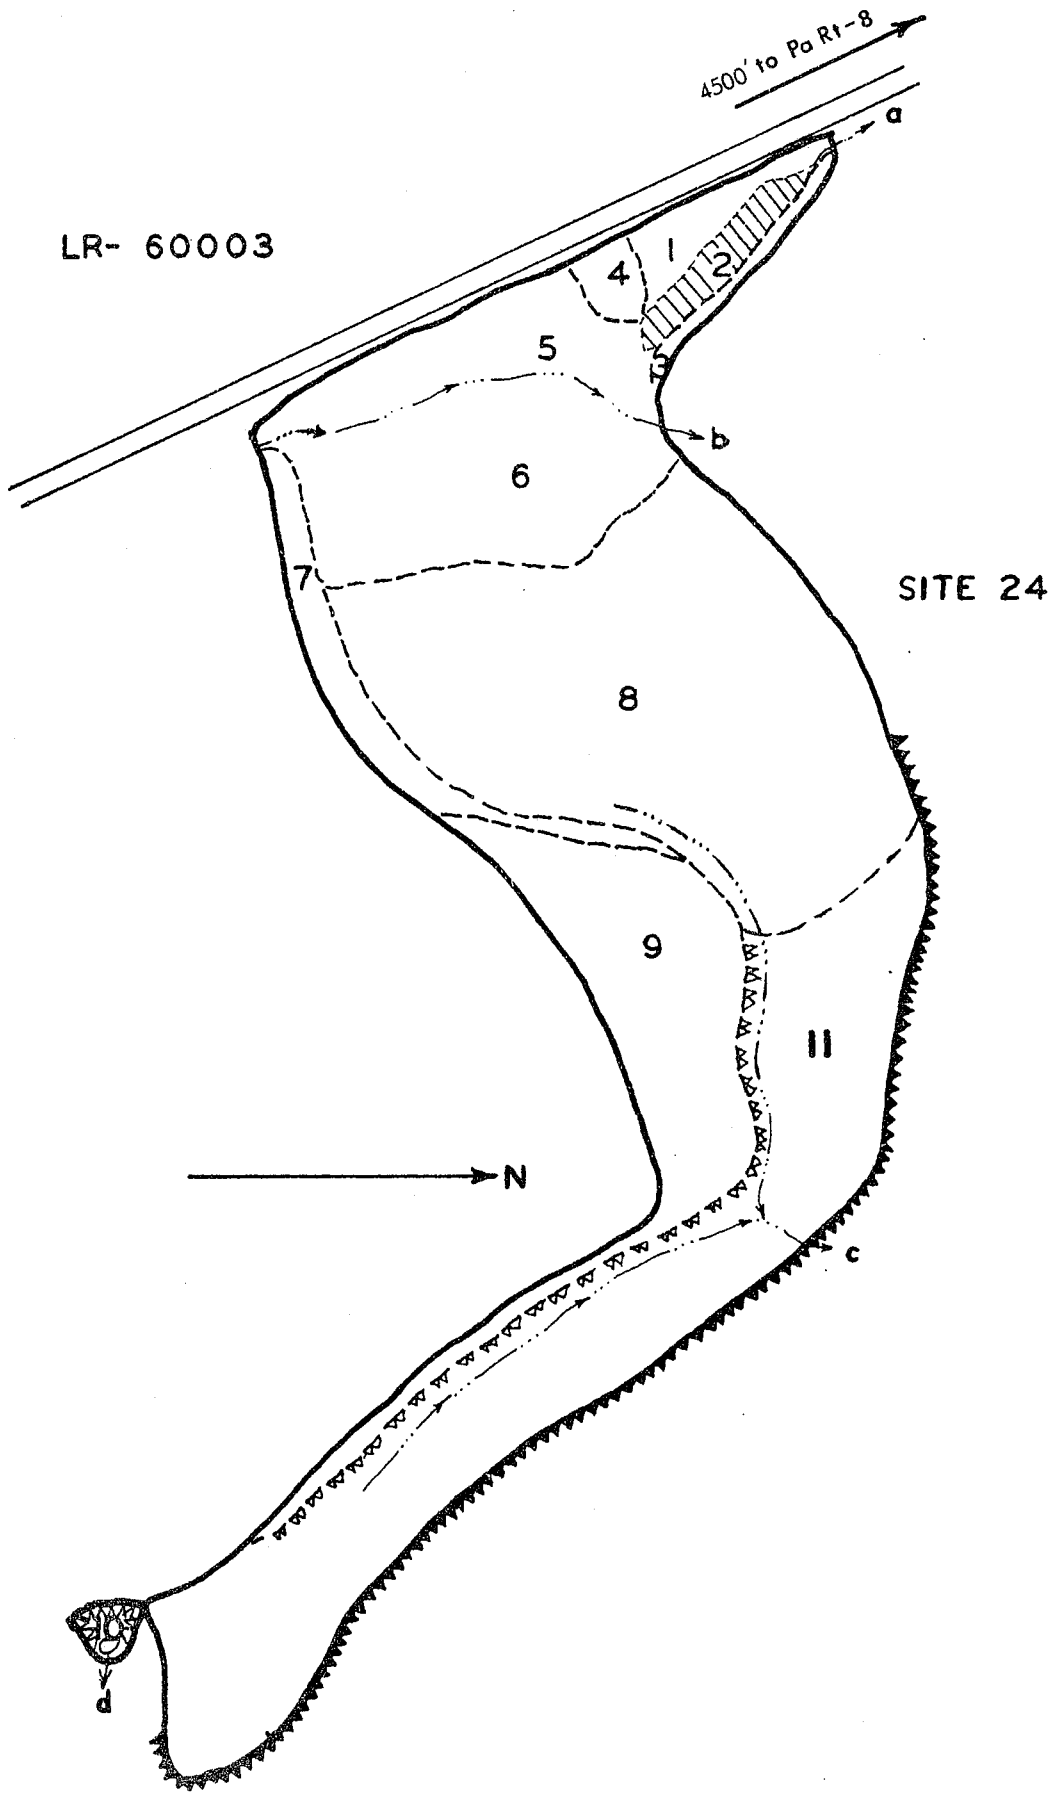
Mine Site No. 24 includes 46.9 acres of strip mine on the east side of L.R. 60003 and just north of Township Road T-325 on the west side of Big Scrubgrass Creek. Some of the area has been planted to trees which are about 12 years old. Spoil pH on this mine is between 4.2 and 4.8.

Areas #1, #2, #3 and #4 cover 2.3 acres of rough area including an area covered with coal waste and an acid pool. Selected grading is needed to drain the acid pool and bury the coal waste under at least 5 feet of compacted neutral soil containing at least 20% clay. The surface should be graded to fit the original contours and reseeded using revegetation Method No. 1.

Areas #5, #6 and #8 cover 23.2 acres which are partially bare, eroding and are a source of acid storm runoff. A small amount of selected grading is required to provide adequate drainage and reduce some excessive slopes and the area should then be reseeded using revegetation Method No. 1. A lined channel should be constructed across the area to carry runoff from above through without having gully erosion.

Areas #7 and #9 cover 8 acres of steep eroding soil at the edge of the mine. A diversion is needed above this area to divert unpolluted water away from the acid source areas below. The diversion should be outletted through the lined channel across Area #6. The area should then be seeded using revegetation Method No. 1.

Area #10 covers 0.3 acres of bare, eroding area which is a source of acid storm runoff. The area needs to be reseeded using revegetation Method No. 1.

Area #11 covers 13.1 acres below the highwall. This area has been regraded to slope back toward the highwall with drainage out through a cut at point "c". The area needs some selected grading to provide adequate drainage during wet weather, and the disturbed area reseeded using revegetation Method No. 1.

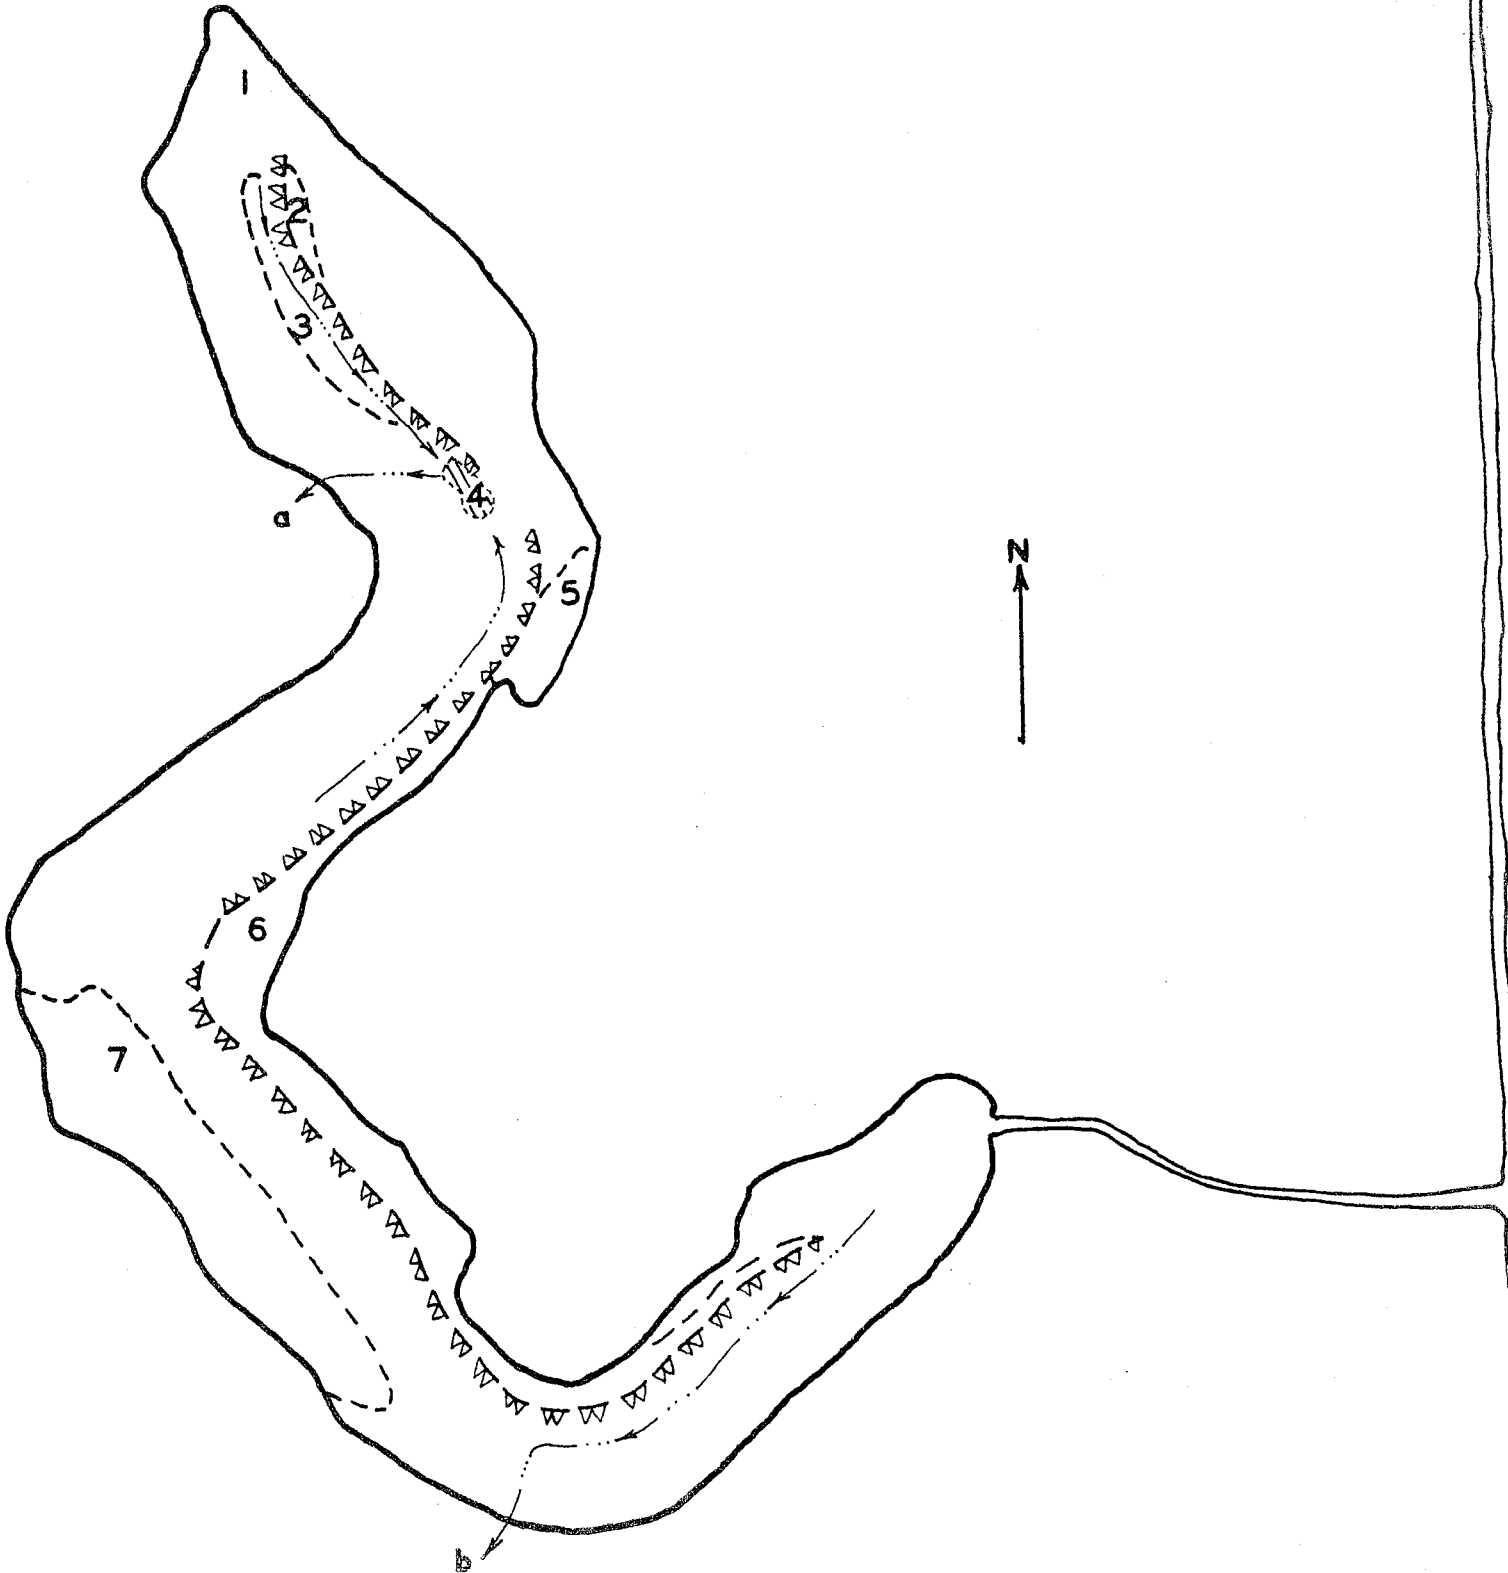
SITE 25

Site No. 25 is a strip mine covering 43.6 acres on the east side of the Upper Main Stream valley south of Township Road T-335. The site is partially regraded with the spoil sloping back toward the highwall. The spoil pH is 4.0 and small acid pools accumulate at the base of the remaining highwall.

Area #1 covers 33.1 acres including some wet weather pools. Some selected grading is needed to provide drainage for these areas and the disturbed areas should be reseeded using revegetation Method No. 1.

Areas #2, #5 and #6 are 4.8 acres of bare, eroding areas above the highwalls. Diversion channels should be constructed at the upper edges of these areas to keep unpolluted runoff water away from the acid source areas in the mine below. These areas should then be planted using revegetation Method No. 5. A lined outlet channel should be constructed to carry the diversion runoff across the mine at point "a".

Area #7 covers 4.3 acres of rough bare acid spoil which is a source of acid storm runoff. This area should be regraded to provide a stable surface and then be reseeded using revegetation Method No. 1.
