THE ABATEMENT PLAN

MUDDY RUN WATERSHED

PROJECT NO. SL-155-1

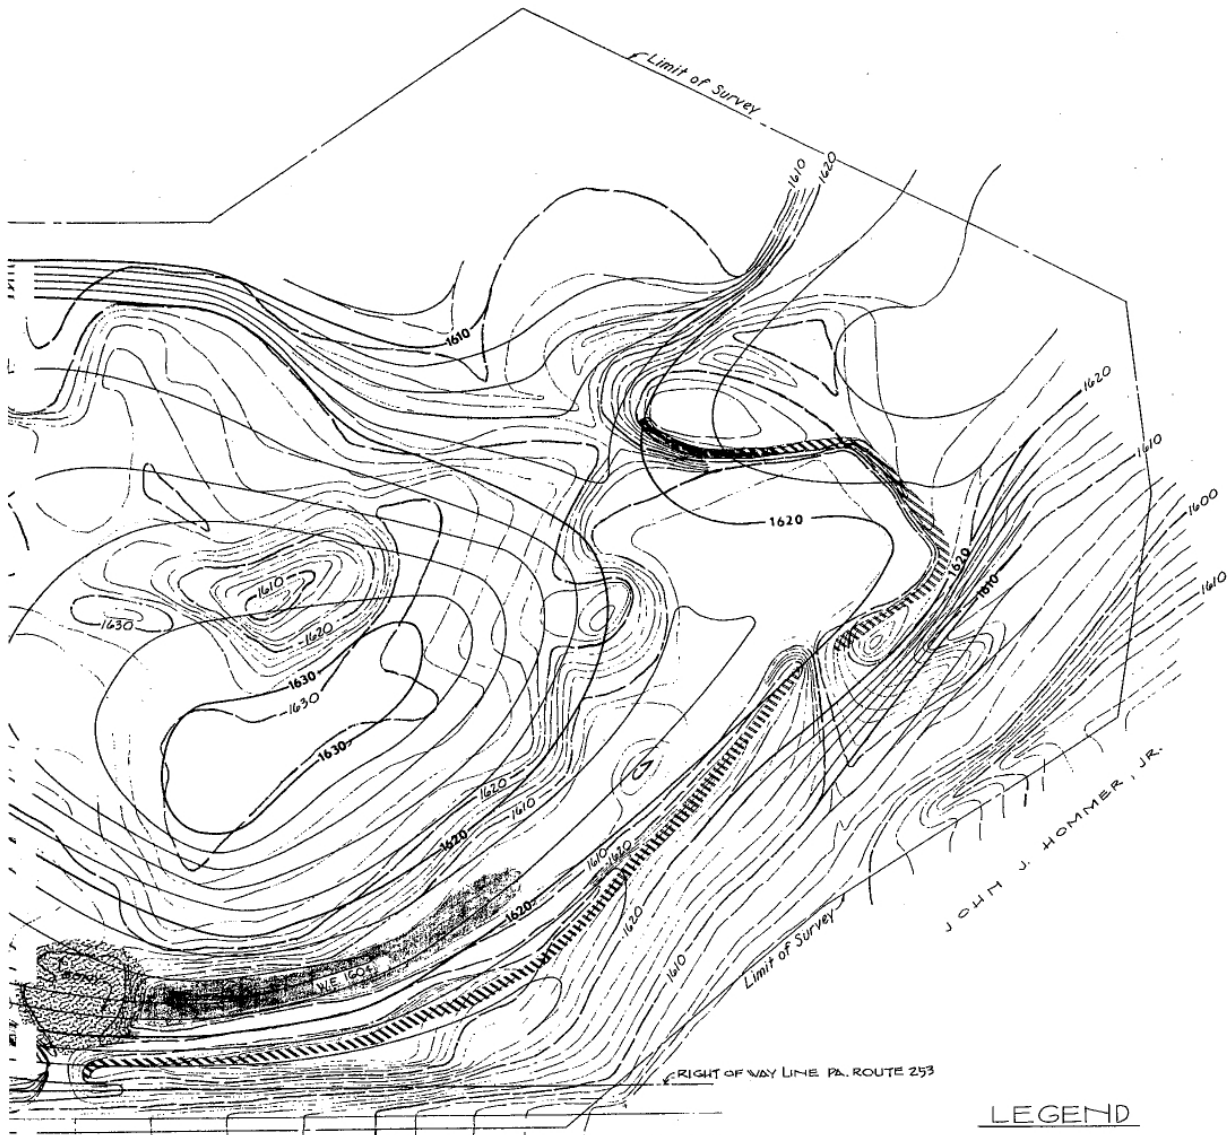
GRADING PLAN

QUICK START NO. 1

Abatement will be accomplished by restoring the stripped area. compacting coal refuse on the bottom of the strip cut; grading the entire area; treating the soil with limestone and fertilizer; and applying seed.
