APPENDIX I

DRAINAGE OUTLETS EXPLANATION SHEET

TANOMA COMPLEX
(UPPER CROOKED CREEK)
MINE DRAINAGE POLLUTION
ABATEMENT PROJECT
PROJECT SL 107-6
INDIANA COUNTY, PENNSYLVANIA
GENERAL INFORMATION MAP

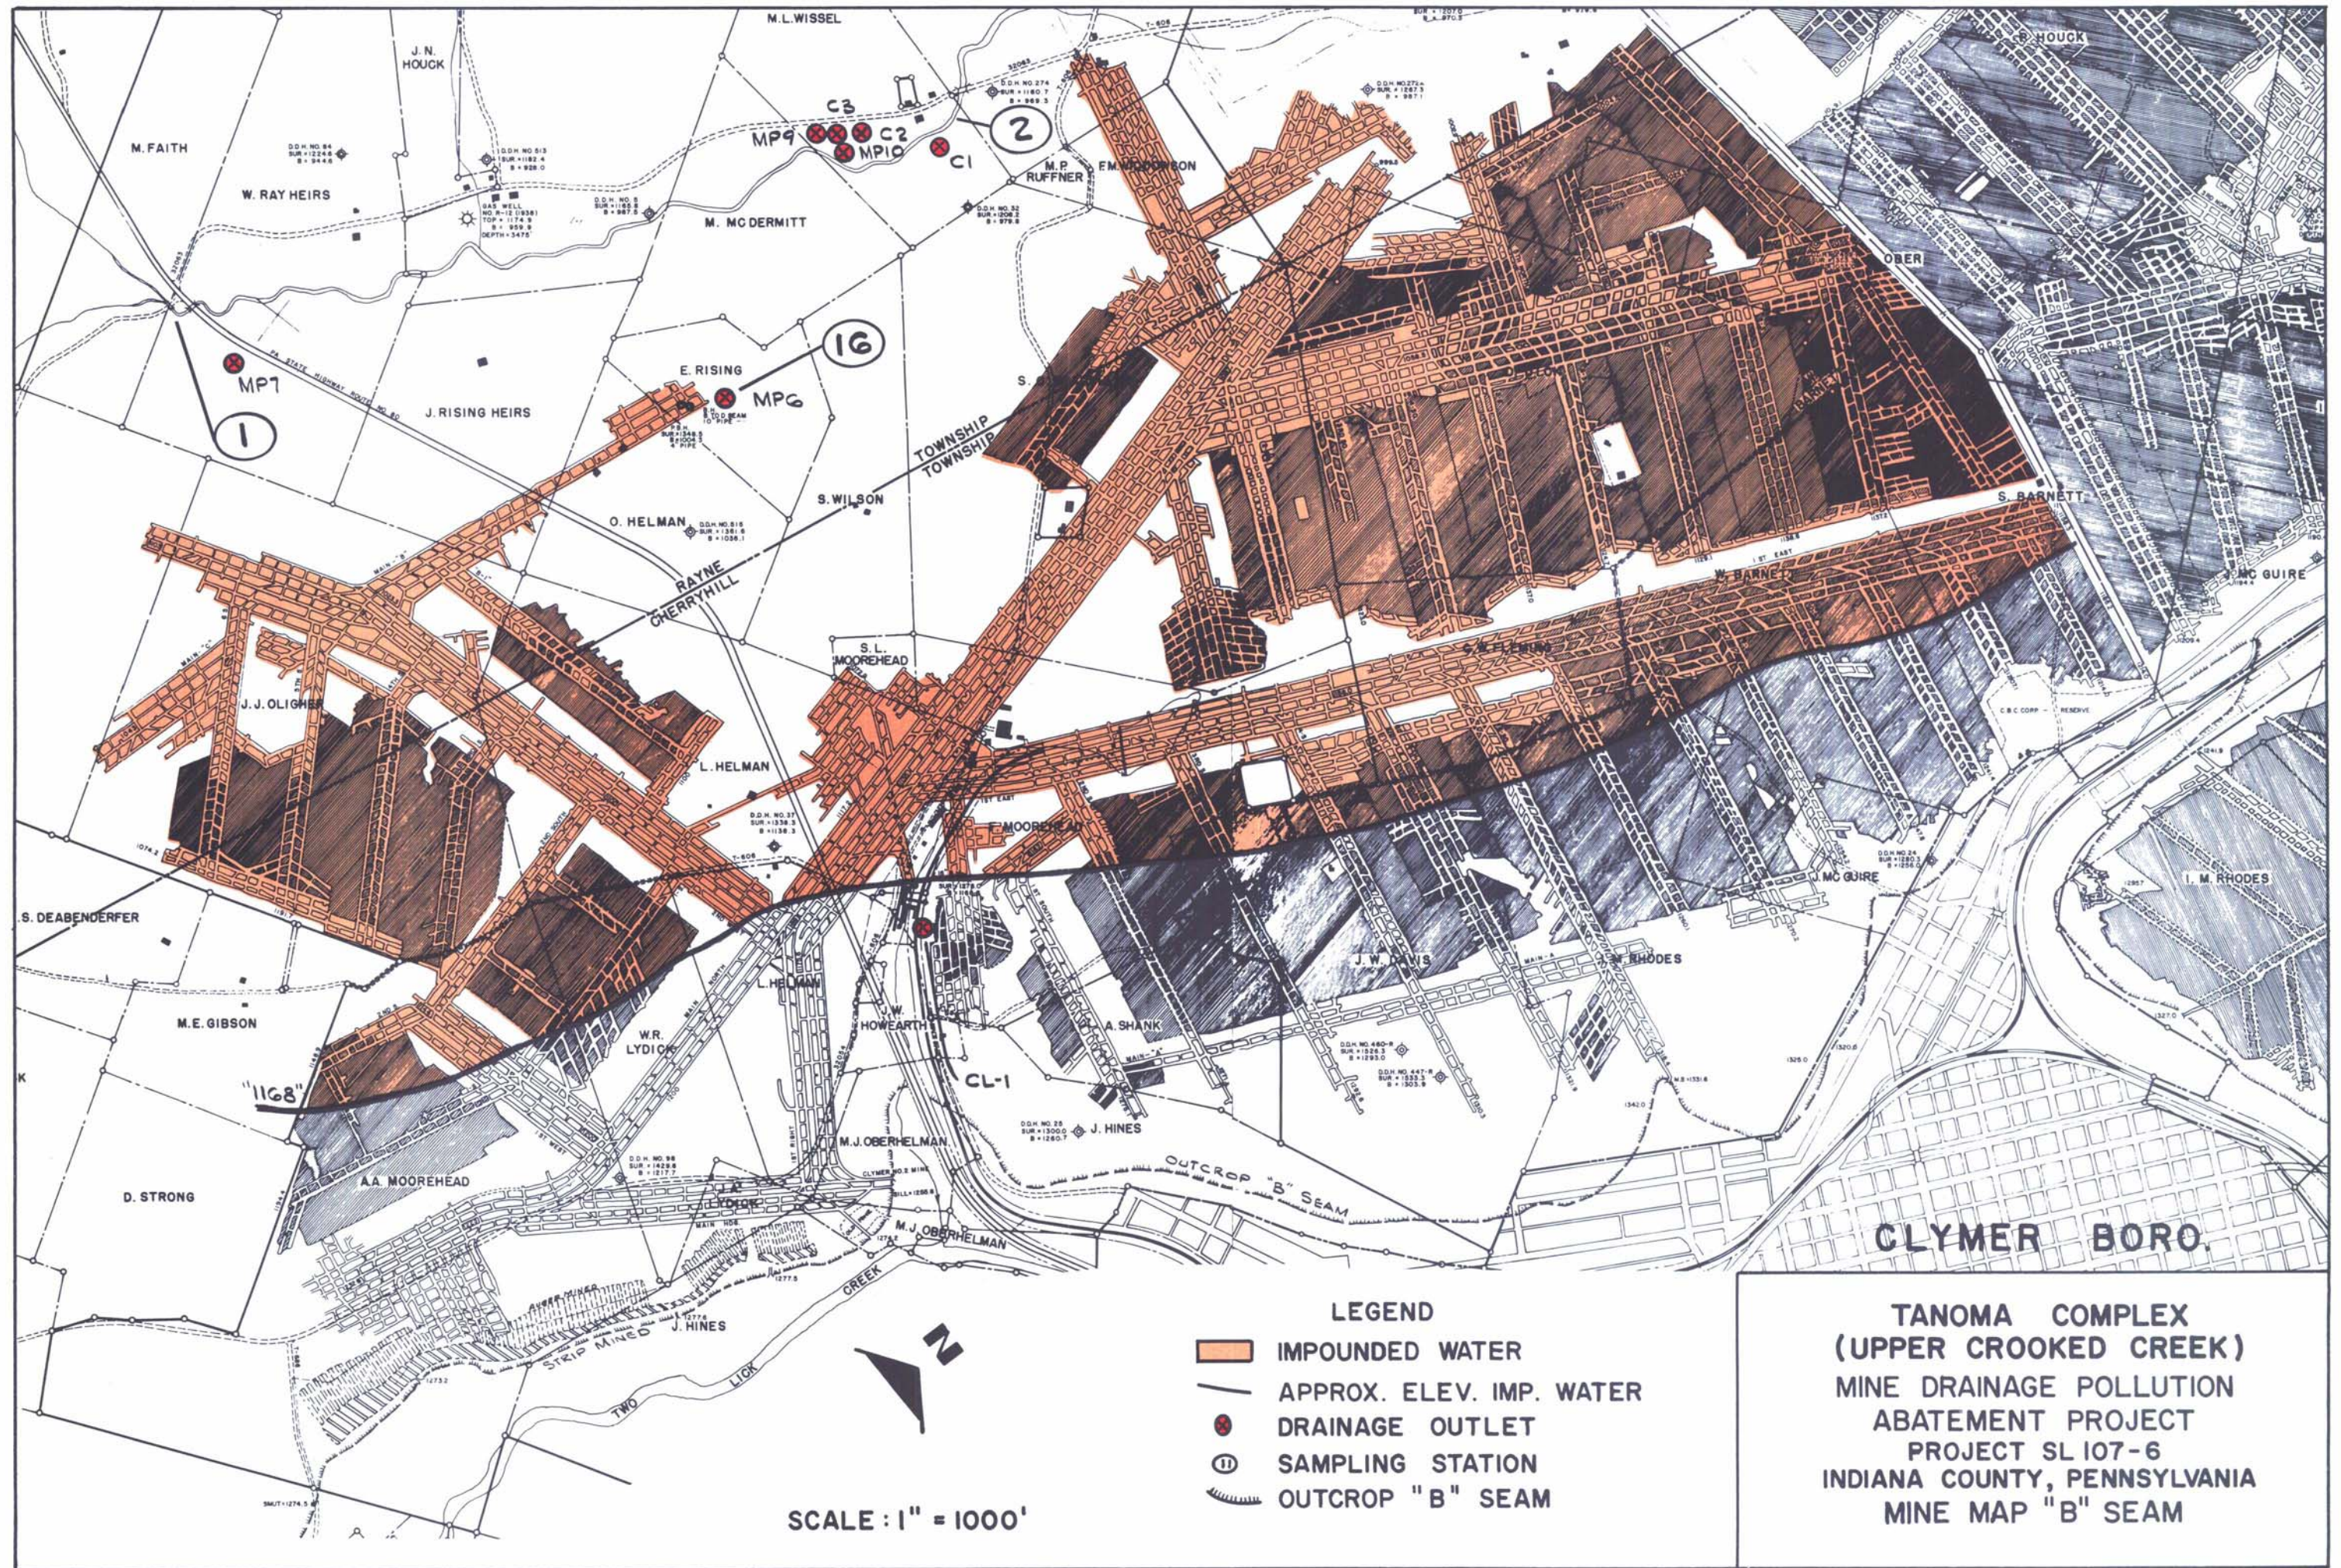
**TANOMA COMPLEX
(UPPER CROOKED CREEK)
MINE DRAINAGE POLLUTION
ABATEMENT PROJECT
PROJECT SL 107-6
INDIANA COUNTY, PENNSYLVANIA
MINE MAP "B" SEAM**

MINE MAPS - LOWER KITTANNING "B" SEAM

These maps are also reproductions of the Clearfield Bituminous Coal Company maps. The mined-out coal seam and structural elevations are the main features of these maps. The drainage outlets and approximate elevation of the impounded water are also shown.
